The Kyrenia Ship Conservation Project

Kyrenia Ship Collection: Conservation Progress Report

May 2017

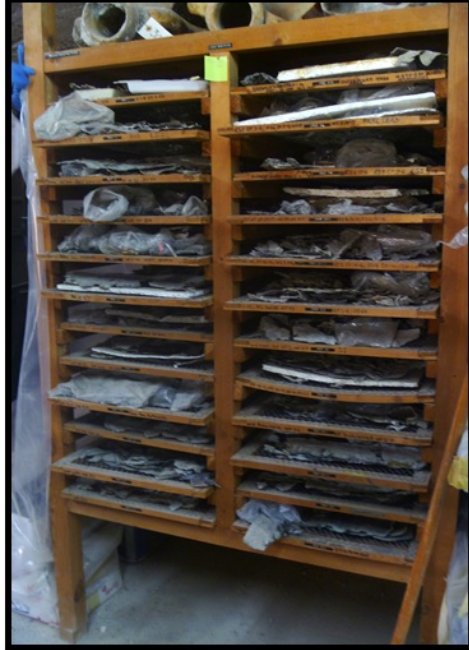
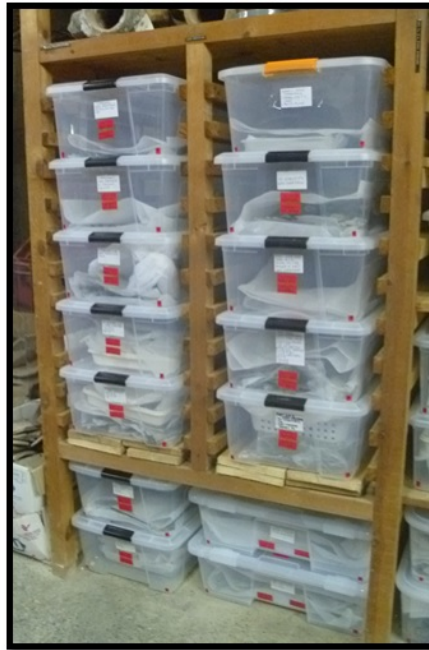
Fig.3: Photograph of the lead sheathing storage before and after the conservators re-housed the material (Photograph courtesy of Cassy Cutulle, 2017).

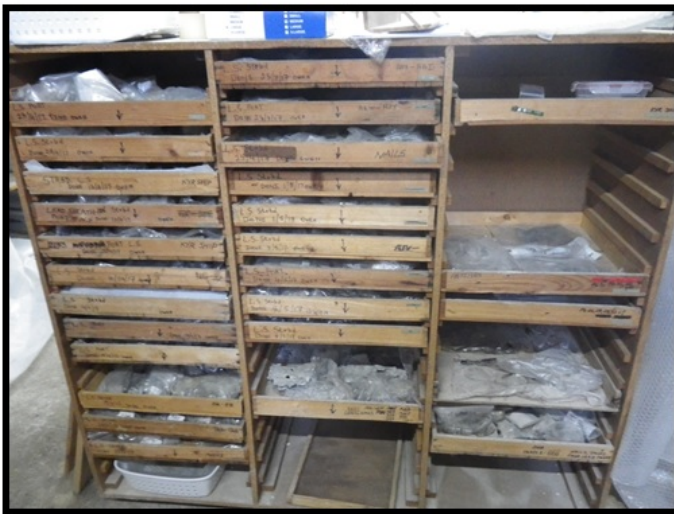
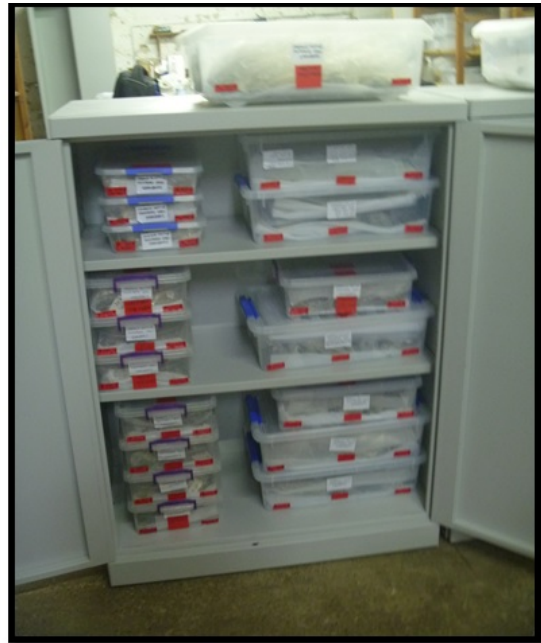
Fig.4: Photograph of the lead sheathing storage before and after the conservators re-housed the material (Photograph courtesy of Cassy Cutulle, 2017).

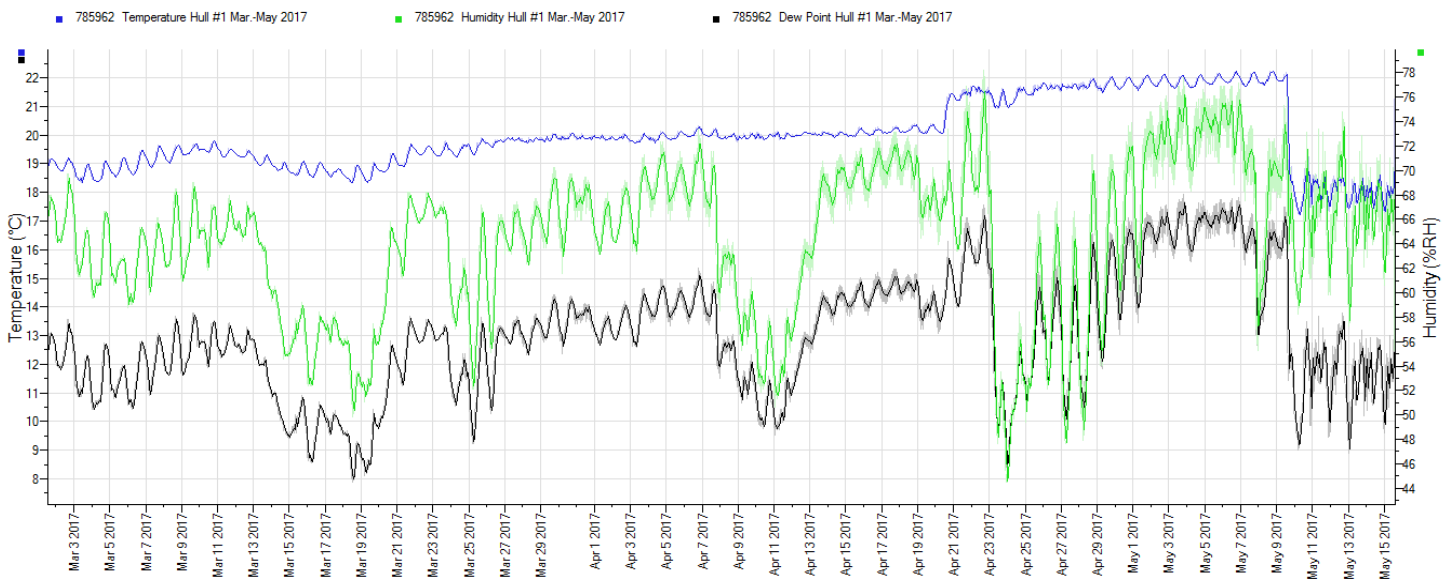
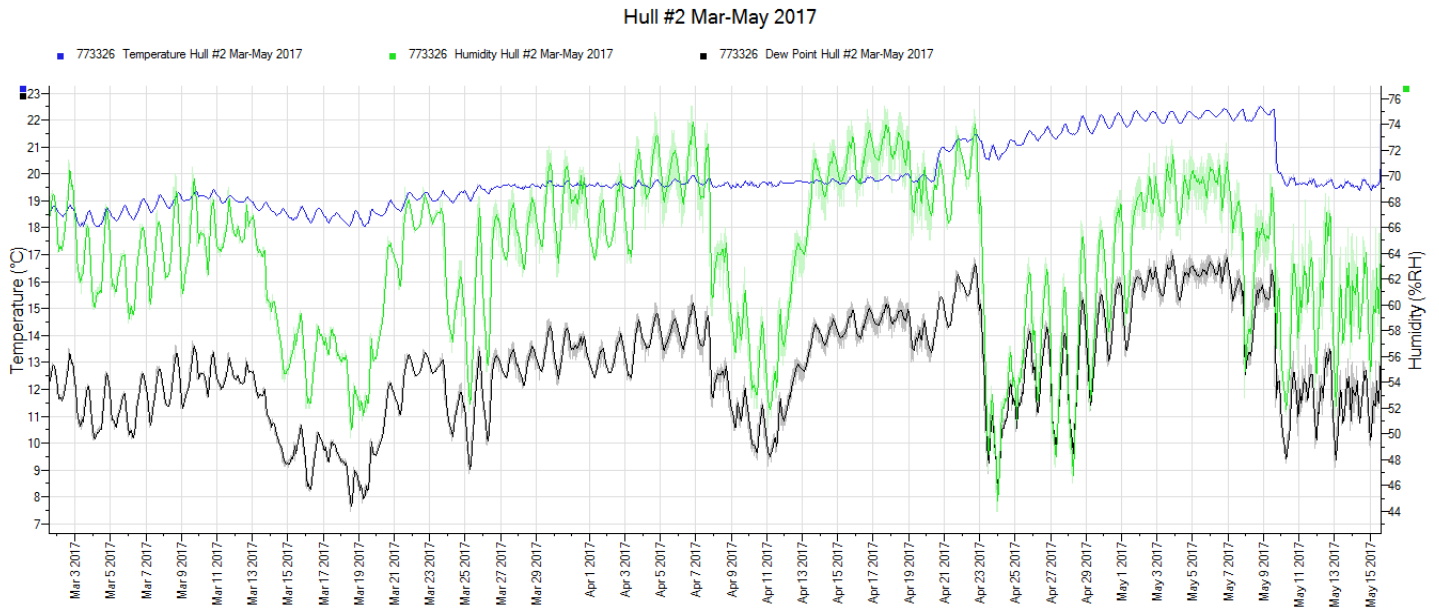
Hull #1 Mar.-May 2017

Figs.8-9: Line graphs displaying the relative humidity and temperature readings throughout March to May 2017 for the data loggers placed on the port and starboard sides of the hull.

Two data loggers were situated within the Ship Gallery: one at the bow area on the starboard side and one at the amidships area on the port side. The data between both loggers is very similar, although the logger placed on the port side shows lower temperature readings as it is on the side opposite the two A/C units in the Ship Gallery. Overall, the temperature readings extracted from both loggers show relatively stable temperatures with gradual, slower fluctuations. Some spikes are evident as the seasonal temperature rises, but again, most changes are slow and gradual, which is ideal. Additionally, the temperature readings are all within the range of 17-22°C, with most falling within the 18-20°C range, which is the most desirable.

The relative humidity for the Ship Gallery is not as stable, however. The frequency of the stark peaks and drops in relative humidity and the large percentage of change is concerning. Fluctuations here are not occurring gradually or slowly, but quickly. These types of variations can be damaging to the wood of the hull, as the wood swells and contracts with the vast changes in humidity in the environment. The readings fall within the overall range of 43-78%, constituting a large degree of difference.

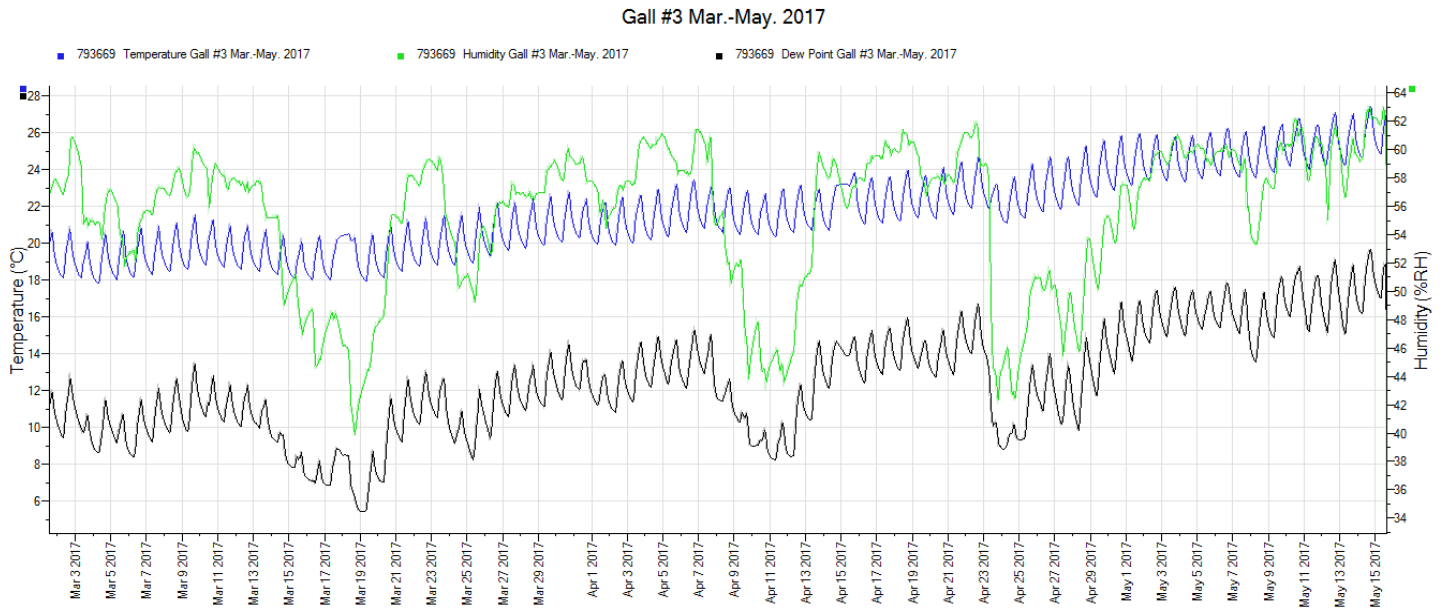
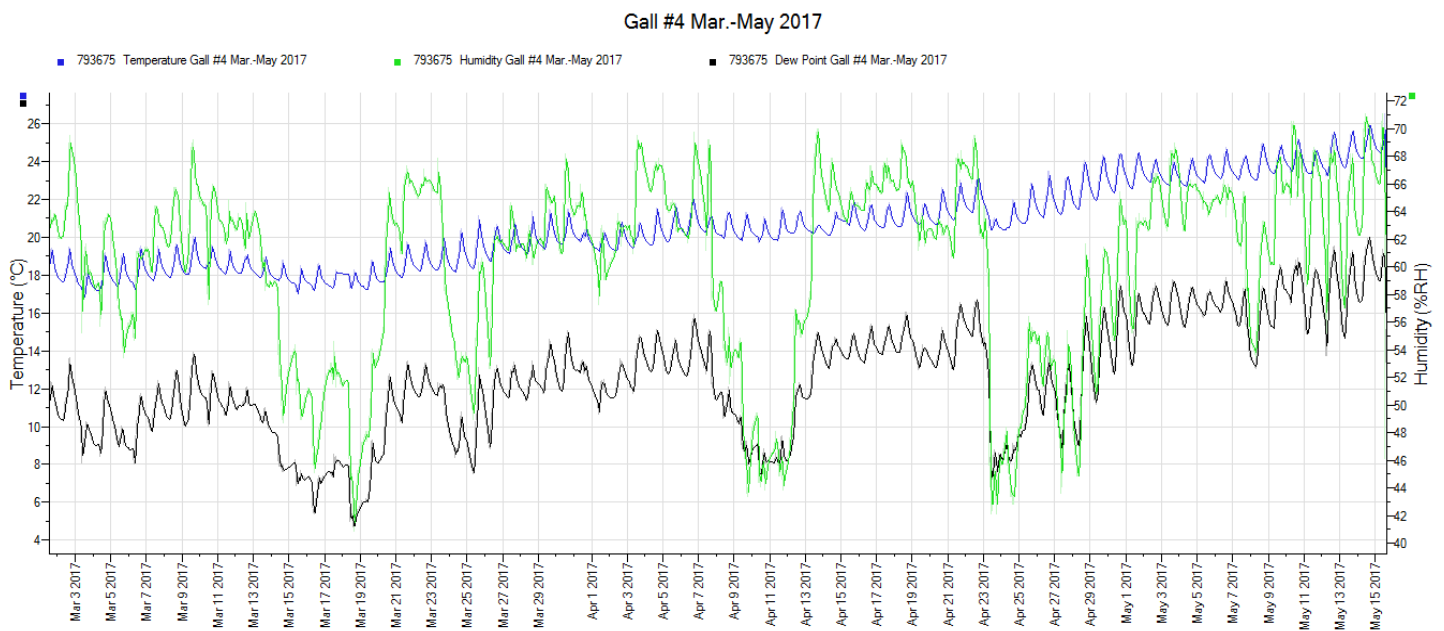
Figs.10-11: Line graphs displaying the relative humidity and temperature readings throughout March to May 2017 for the data loggers placed within the first and tenth display cases in the Shipwreck Museum Gallery.

For the Shipwreck Museum Gallery loggers, similar data was seen throughout March to May as was examined in previous months. For temperature, readings fell within the range of 16-27°C, which does need stabilization to 19-22°C, preferably. Peaks and drops in temperature followed a particular zig-zag pattern, indicative of the turning on and off of lights within the cases each day. Although the fluctuations do follow a regular progression, stabilization is desirable in the future. This can most likely be effected through installation of lighting within the cases that does not emit heat.

The relative humidity readings within the display cases are concerning as the fluctuations present are frequent with large drops and quick increases. In particular, these types of changes in relative humidity can create an environment that encourages the formation of corrosion on metal objects, mold growth and cracking/warping of both inorganic and organic objects. The installation of new lights should aid in stabilizing the relative humidity to a degree, however, the lack of any environmental controls in the Shipwreck Museum Gallery and the construction of the cases are other important factors affecting these readings.

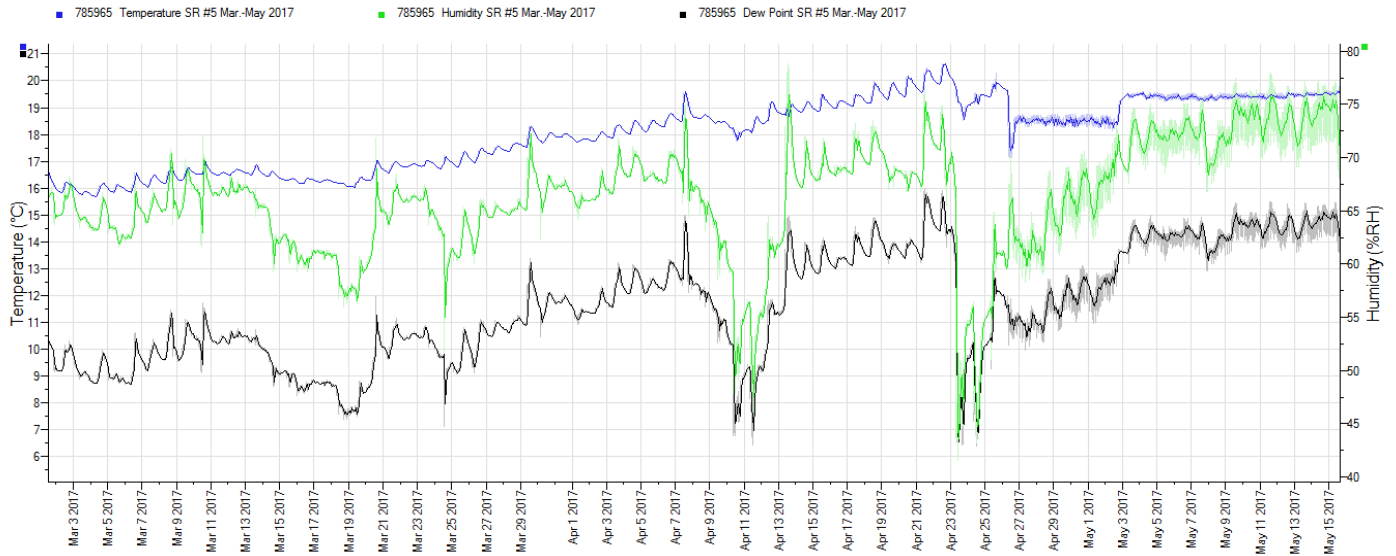
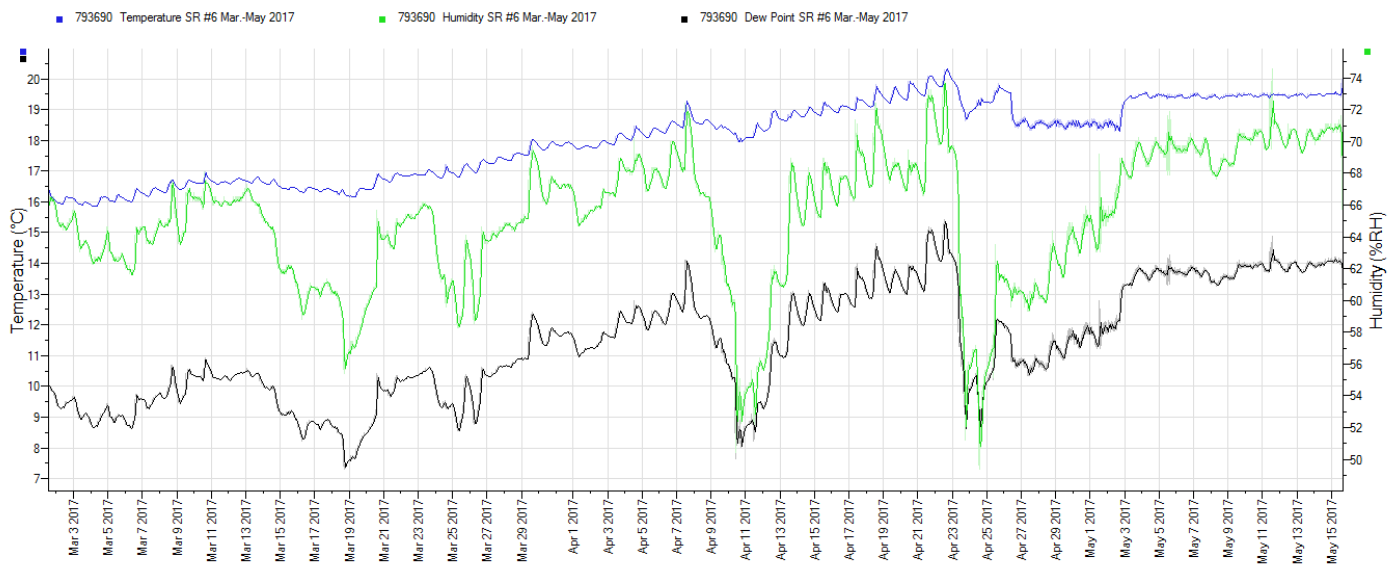
SR #5 Mar.-May 2017

Figs.12-13: Line graphs displaying the relative humidity and temperature readings throughout March to May 2017 for the data loggers placed within the Kyrenia Ship Storeroom.

Within the Kyrenia Ship Storeroom, the readings from both loggers appear quite similar. The temperature readings are quite stable, with gradual fluctuations present. The installation of the A/C unit can be seen in late April, which has greatly reduced the degree of fluctuation present. The A/C has stabilized the temperature to about 19.5-20°C, which is particularly ideal climate for the Storeroom environment.

Prior to the A/C installation, the relative humidity was not stable, and the readings shows erratic and irregular fluctuations over a large magnitude of change. However, in late April, the percentage stabilized as a result of the A/C, with variations that showed a smaller degree of change. However, the use of the A/C has caused the relative humidity to stabilize at a higher percentage (around 71%), which is not ideal as this can cause mold growth, metal corrosion and warping of objects. This higher humidity is a result of the A/C cooling the air, which subsequently allows the air to carry more moisture. As temperature drops, the humidity will then rise. To try to combat this, the conservators tested different settings for the A/C unit to assess which would provide the lowest humidity at about 58-60%, which is much more appropriate. As a result, it seems that the heating setting for the A/C with a temperature set to 27°C provides the lowest humidity in the Storeroom. These settings can be changed for comfort when working in the Storeroom as long as they are turned back to the optimum settings (“heat” at 27°C) after. In the future, a dehumidifier would be ideal to further bring down the humidity to around 50-55% as the air conditioning unit is not capable of dehumidifying to a large degree.

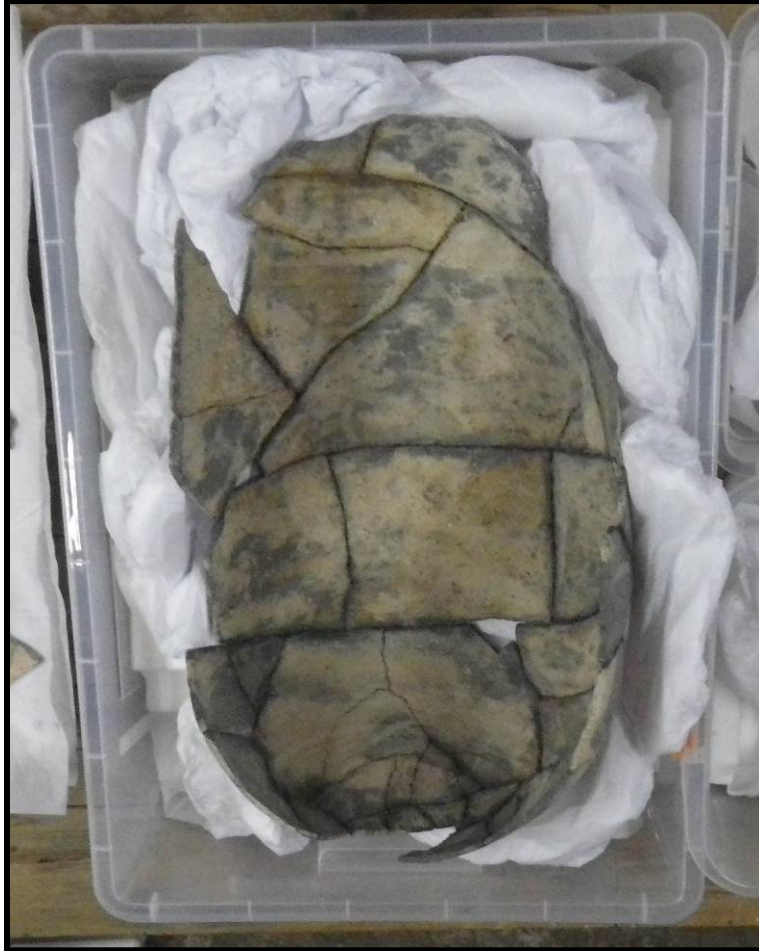
At the end of April, much of the remedial treatment work had been completed, with the exception of the restoration of two ceramics P15 and P21. Cassy completed the detachable plaster fill for P15 and painted the area in time for it to go on display at Kyrenia Castle in late May. Veronica also finished the sanding of P21, concluding its treatment. A final challenge was to continue the reconstruction of the large amphora P113, which was particularly time consuming due to its size. Due to an accidental breakage which occurred during transport, this object required additional reconstruction, which was carried out during the end of May, returning it to its pre-transport condition.

Fig. 17: Photograph of P113 after its reconstruction after the accidental breakage during transport (Photograph courtesy of Veronica Ford, 2017).
