FINAL REPORT SUMMARY:

THE CONSERVATION OF FINDS FROM
UNDERWATER EXCAVATIONS AND SURVEYS -
CONTRACT FOR THE PROVISION OF SERVICES
FOR THE DEPARTMENT OF ANTIQUITIES,
CYPRUS

Constantina Hadjivasili

April 2021

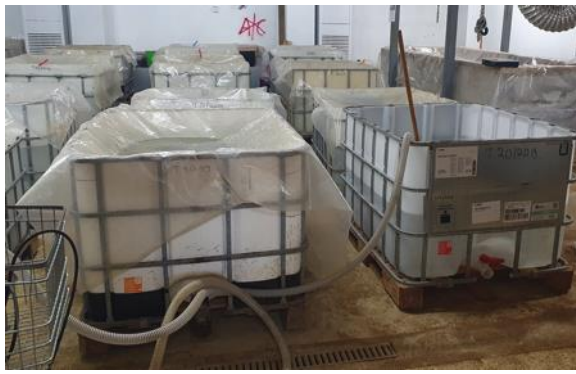
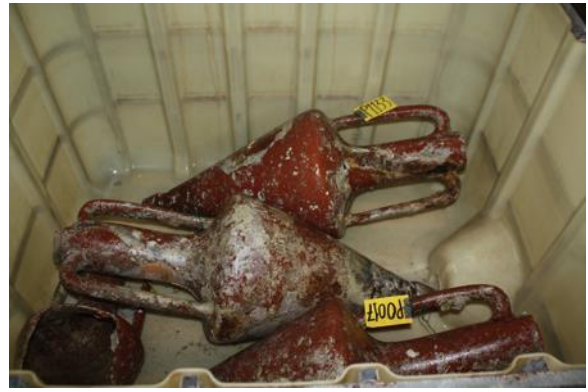
This process included the desalination of finds (intact amphorae, parts of amphorae, groups of sherds) from 2019 excavations and surveys. At the time of commencement of the contract, these ceramics finds, which had been divided in more than 35 tanks, were in the last stages of desalination. Water baths were changed until conductivity levels were low and chlorides remained below 50 mg/l. The water was replaced 3 times, with the same water volume in each tank, with Reverse Osmosis water. When desalination was completed, the water was pumped out from the tanks and the ceramics finds were left inside the tanks to air-dry slowly (fig. 1).

Fig. 1: Pumping the water out of the tank. Amphorae during air-drying.

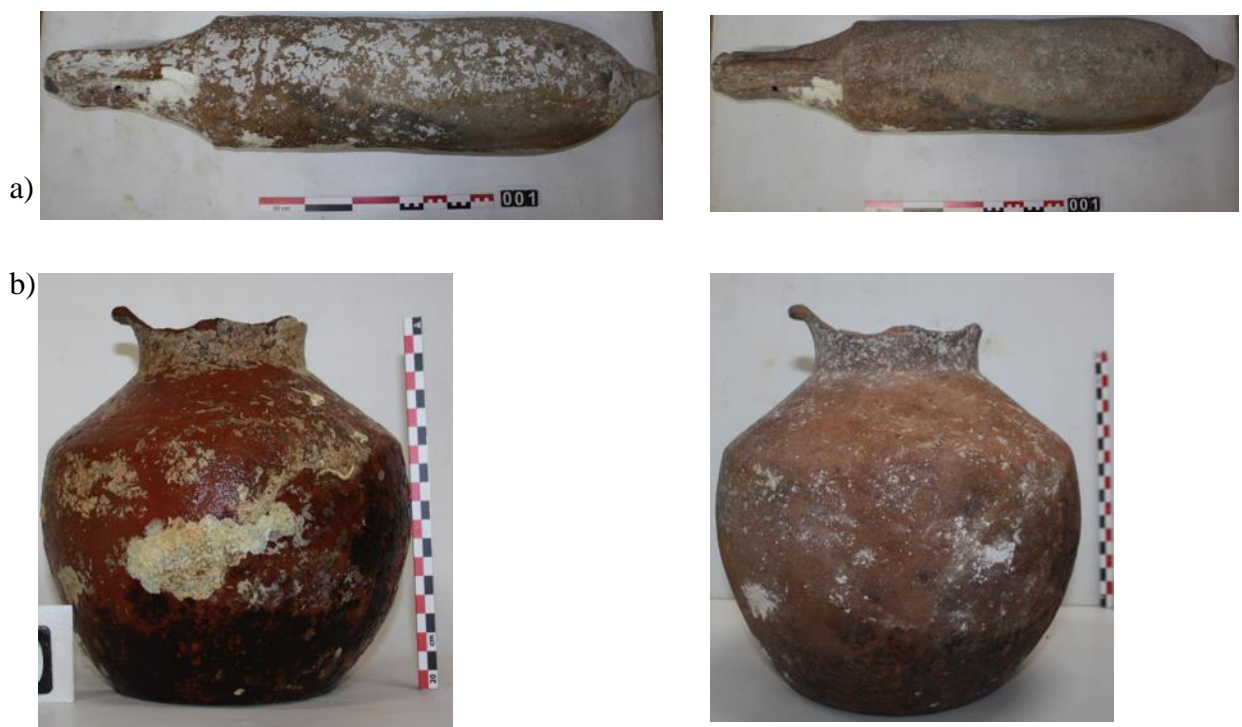
The cleaning procedure involved the removal of the calcareous deposits covering the surface of the objects recovered from the Protaras shipwreck excavation in 2019 and from the Dreamer's Bay underwater surveys in 2018 and 2019 (fig. 2). The removal of calcareous crusts and hard marine particles is a big intervention, but essential because the encrustations could be covering significant decoration or manufacture details. The commonly adopted procedure was mainly based on mechanical cleaning (scalpel, pin, chisels), that was carried out in a very gentle and careful way, avoiding any surface damage. The level of cleaning for each ceramic object was dependent on the nature of both the pottery and deposits and also on the strength of their attachment to the pottery surface. Very hard deposits strongly adhered on unstable surfaces were removed to the extent possible without damaging the original surface.

Fig. 2 (a,b): Amphora (ESEA 19-19) and Jug (ESEA 30-19) before and after mechanical cleaning.

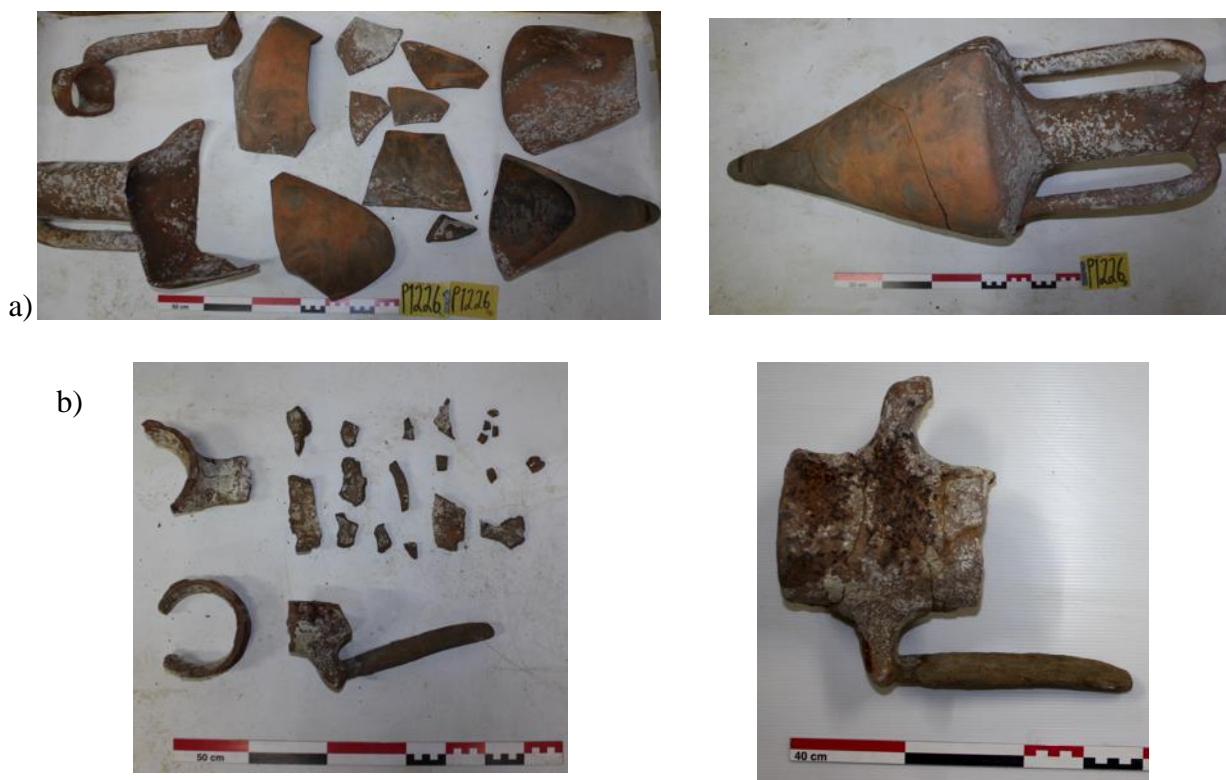
Reassembling broken ceramics (fragmented amphorae or parts of amphorae) from the Mazotos and Protaras shipwrecks 2019 excavations was also part of this contract. Finds were adhered with HMG Cellulose Nitrate adhesive.

Fig. 3 (a,b): Amphora (ESEA 221-19) and Upper part of an amphora (ESEA 34-19) before and after adhesion.

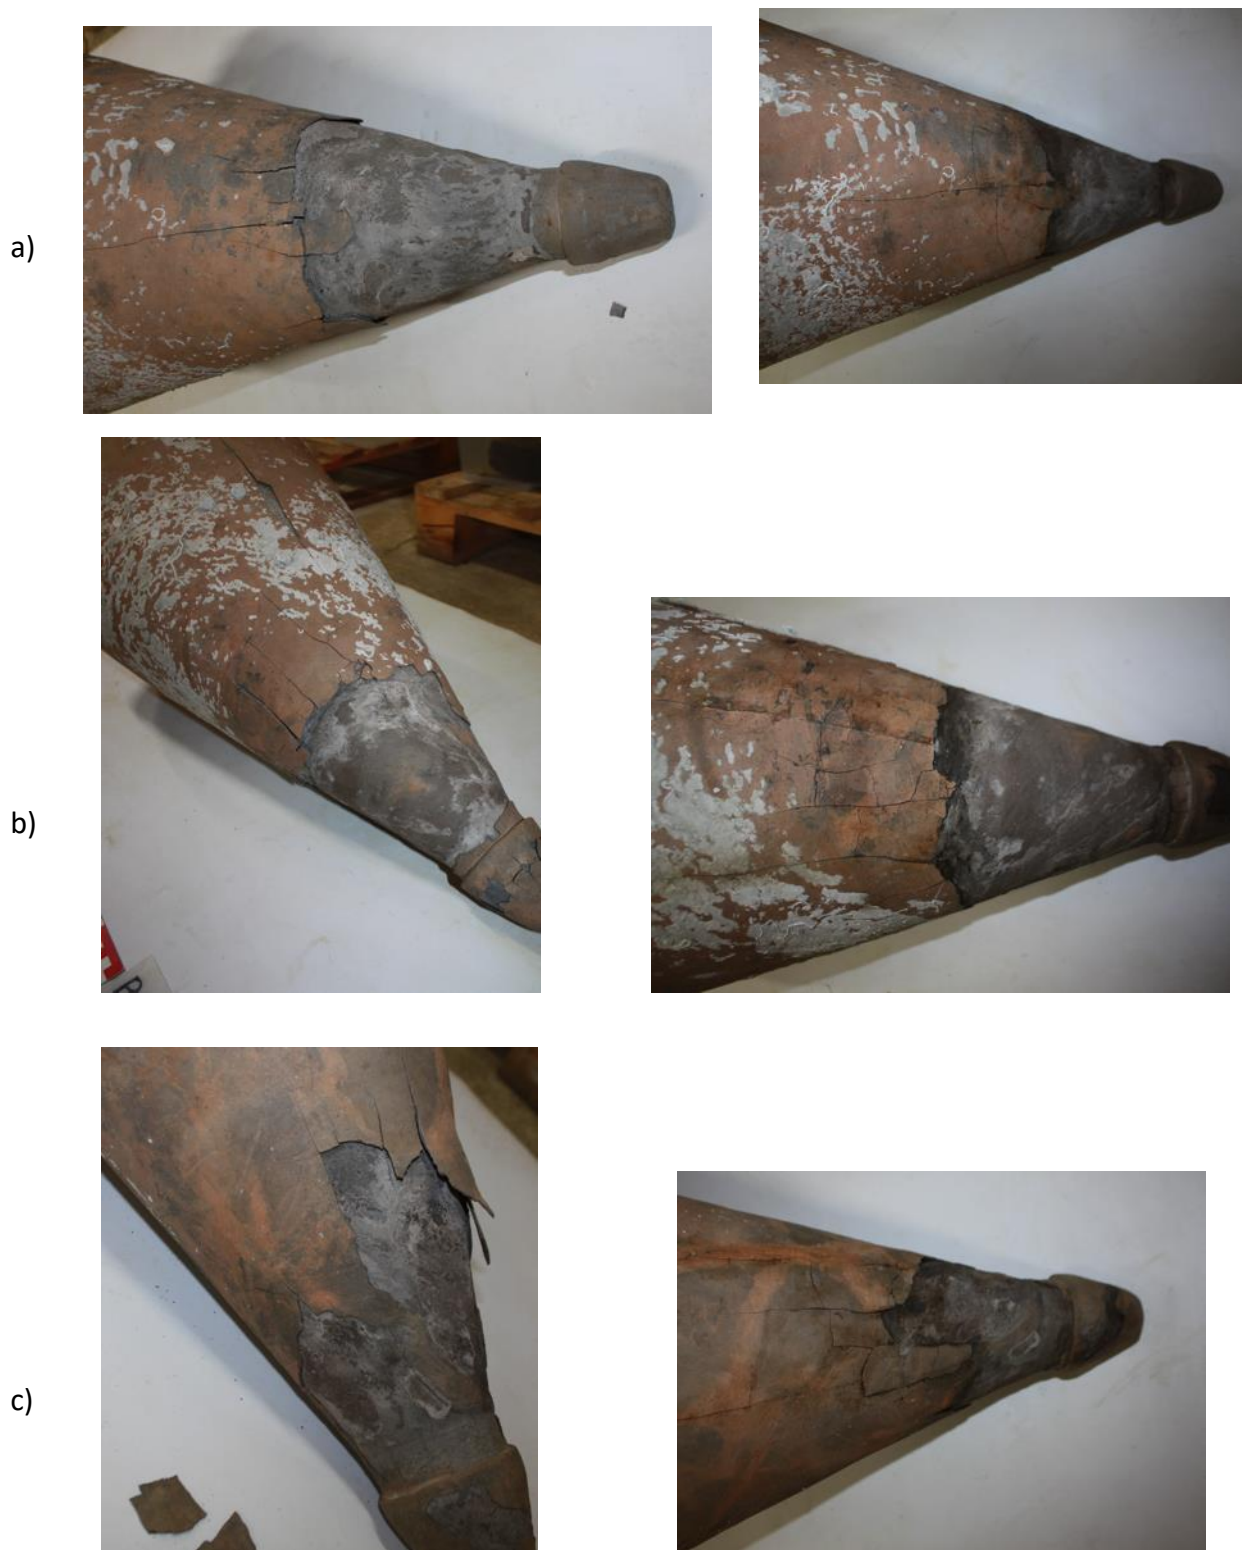
A total of 20 finds (intact amphorae, parts of amphorae), from 2018 Mazotos excavation, required consolidation. The observed damage phenomena concerning the surface of the amphorae can be characterised as exfoliation and flaking off of the original surface and formation of micro-cracks. Loose flakes or edges around losses and cracks required local or overall consolidation to prevent further damage. Flaking areas and micro-cracks were consolidated with the injection of 5%-20% solution of Paraloid B-72 dissolved in acetone. Edges around losses were strengthened with

Fig. 4 (a,b,c): Amphorae (ESEA 262-18, 263-18, 271-18) before and after consolidation.

HMG Cellulose Nitrate adhesive. Excess consolidant was removed with acetone applied on cotton wool swabs (fig.4).

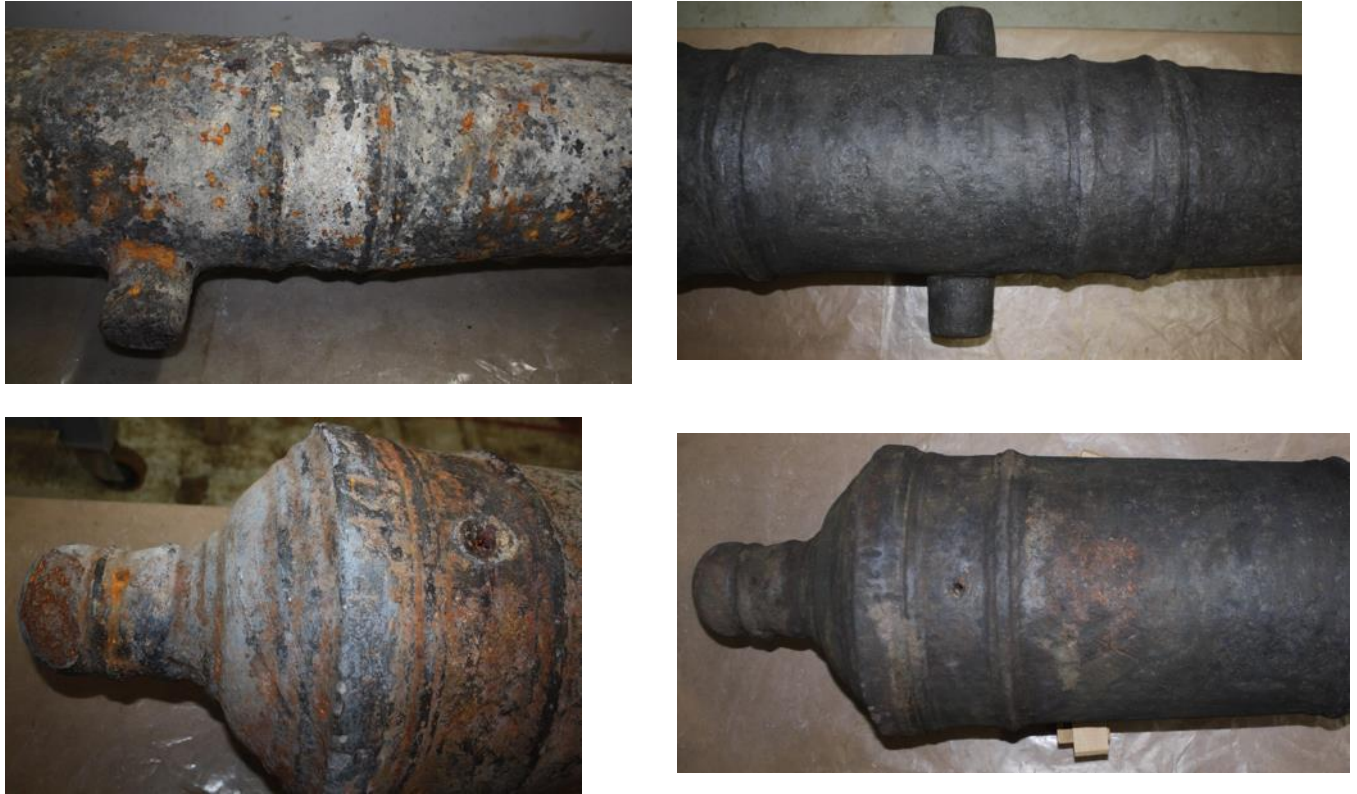
In September 2014 a cast iron cannon was lifted from the Nissia wreck. During the following years the cannon was mechanically deconcreted, desalinated and air-dried by the DoA. After these conservation steps, a thin layer of encrustations and localised corrosion products still remained on its surface. Removing these, completing the surface cleaning and applying a protective coating, in collaboration with DoA staff, was required in order to conclude the conservation treatment of the object.

Fig. 6 : Iron cannon (ESEA 62-14) before and after cleaning.

A combination of mechanical techniques was carefully applied to clean the surface. Sandblasting with an abrasive aggregate proved useful in removing large areas of concretion and the superficial corrosion; Small hand-held tools such as a scalpel and chisel were effective in removing more dense areas of concretion.

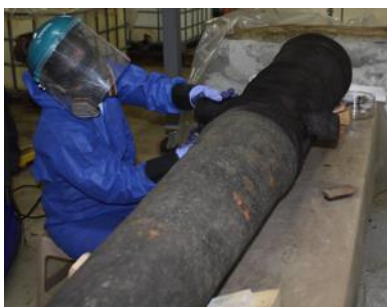
Fig. 7: Application of Tannic Acid solution.

In order to provide a barrier against the atmosphere, thereby preventing further corrosion, the cannon had to be coated. The stabilization of the iron cannon was achieved by brushing it with two coats of 2.5% Tannic Acid solution (fig. 7,8). Tannic acid is an inhibitor that reacts with iron ions to form ferric tannate. The ferric tannate forms a passivation layer on the surface of the cannon, which will protect the underlying surface from corrosion.

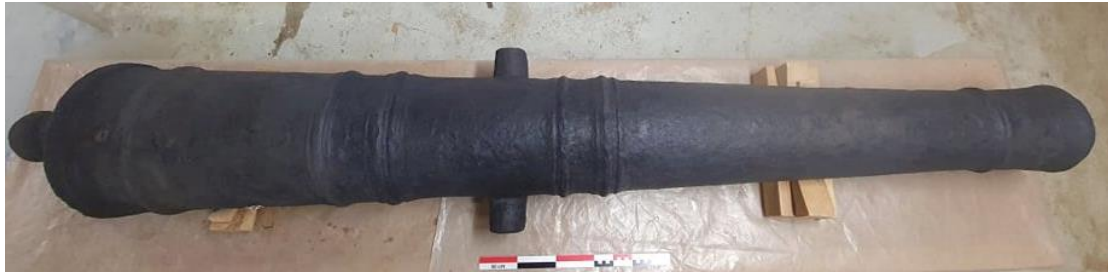
Fig. 8: Cannon after conservation treatments
