The Kyrenia Ship Conservation Project

Kyrenia Ship Collection: Conservation Progress Report

May 2017

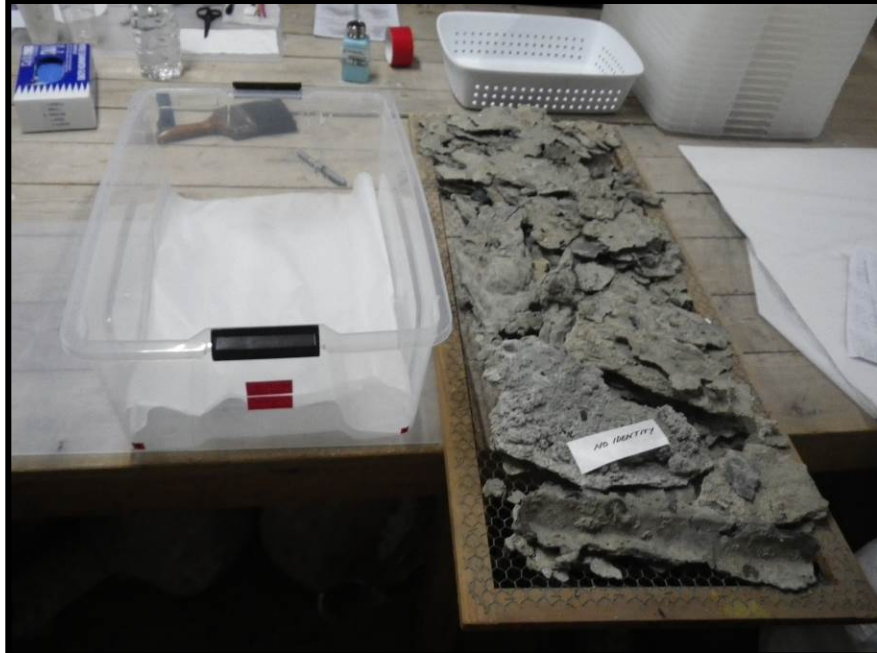
One of the largest groups of objects for re-housing included the lead sheathing stored on chicken wire trays in the Kyrenia Ship Storeroom. This sheathing was originally placed on the exterior of the hull of the Ship and was excavated from the seabed in many pieces. Due to environment of the Storeroom, the lead had corroded over time, becoming weakened, powdery and discolored. The large sizes and quantity of lead pieces made it a difficult re-housing project, requiring special airtight archival boxes. Furthermore, as corroding lead and lead dust is particularly toxic, this project posed many health and safety hazards, which the conservators prepared for. Lab coats, nitrile gloves, hair covers and high efficiency filter face masks were all worn when working with the lead.

For the lead, it was critical that it was stored in archival-quality boxes with minimal air exchange. This is due to the fact that the moisture as well as volatile organic compounds off gassing from the wooden shelves in the air of the Storeroom environment are particularly damaging to the lead. Additionally, the large dimensions of the lead were challenging and the conservators needed to purchase boxes that best accommodated this. Research was conducted and the appropriate boxes were sourced from Energon—a chemical and laboratory supplies company that was utilized in the past to obtain the water deionizing unit. Fifty polypropylene boxes with clip lids were purchased and delivered in mid-May. The clip lids were especially useful as they minimized air exchange with the outside environment more than traditional snap-in lids. Additionally, the placement of the lead in secure boxes such as these meant that the risk of exposure to lead and lead dust was greatly reduced, making the Storeroom a safer environment for people to work in.

Fig.1: Photograph during the re-housing of a tray of lead sheathing into an archival plastic box with clip-lid (Photograph courtesy of Veronica Ford, 2017).

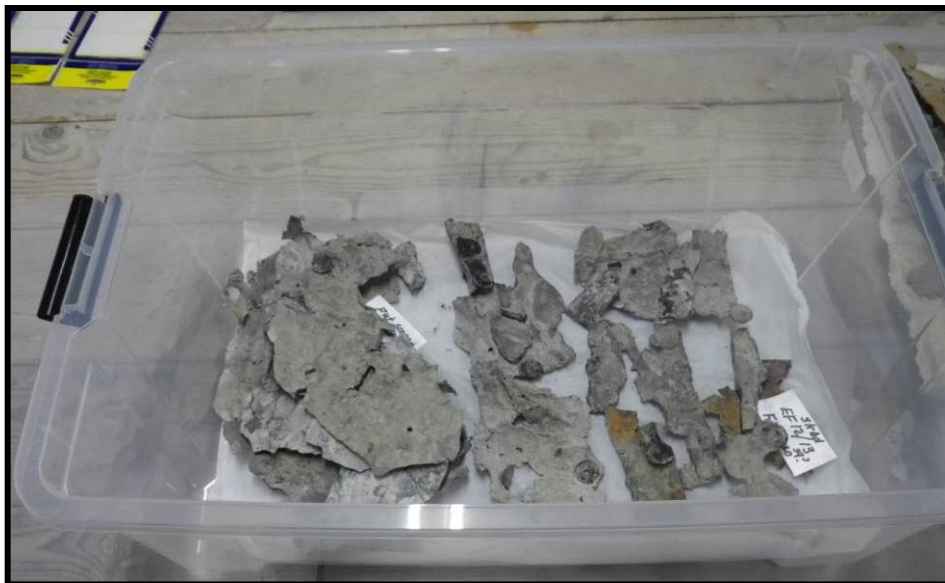
Veronica and Cassy worked throughout the span of 3.5 weeks to store the lead sheathing. The sheathing pieces were re-housed one-by-one by their original chicken wire trays. In most cases, one tray was possible to fit into one box. Often times, the lead was placed into the box in layers. When layered, the lead was supported by an archival plastic tray or smaller box lid. Oversize pieces were placed in some larger boxes left over from the storage of the wooden hull pieces. In all boxes, acid-free tissue paper was placed in the interior base, over any layers present and on the very top of the lead prior to closing the lid.

Fig.2: Photograph showing the placement of lead sheathing within the archival plastic boxes.

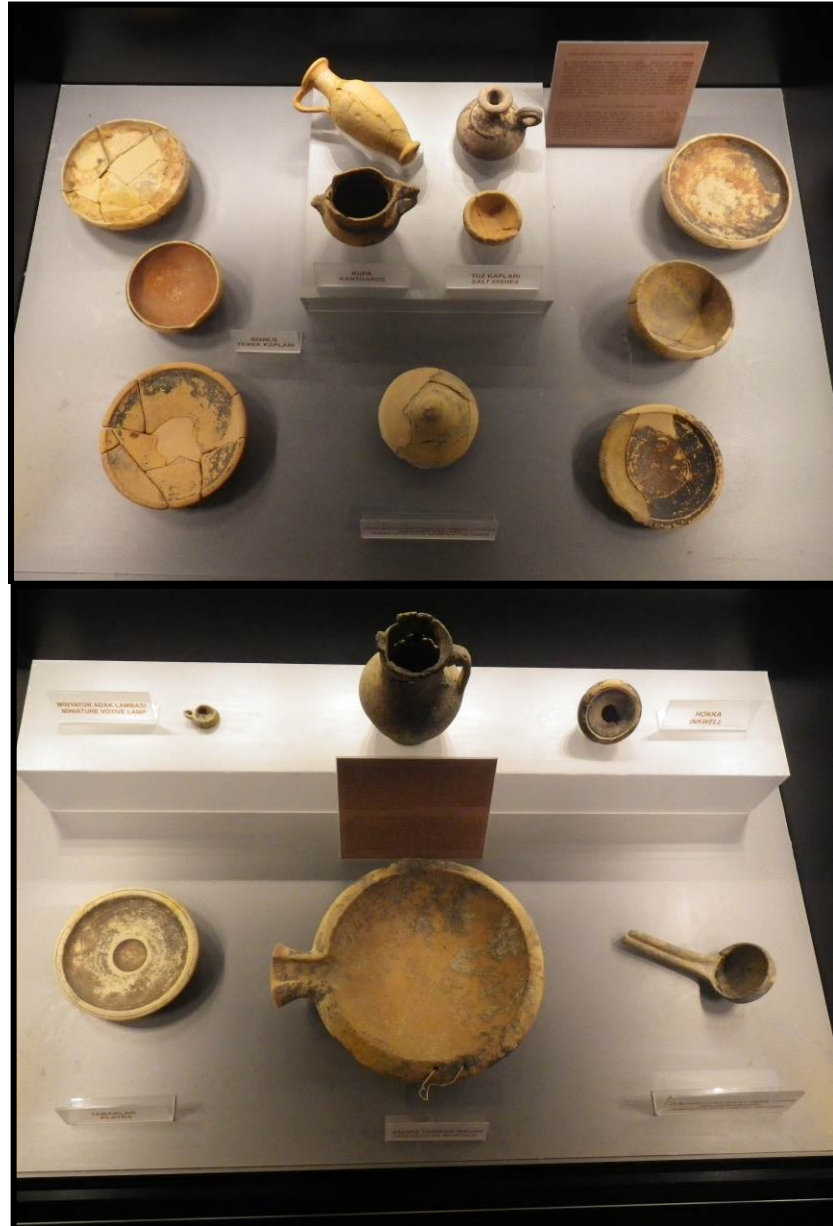
At the end of April, much of the remedial treatment work had been completed, with the exception of the restoration of two ceramics P15 and P21. Cassy completed the detachable plaster fill for P15 and painted the area in time for it to go on display at Kyrenia Castle in late May. Veronica also finished the sanding of P21, concluding its treatment. A final challenge was to continue the reconstruction of the large amphora P113, which was particularly time consuming due to its size. Due to an accidental breakage which occurred during transport, this object required additional reconstruction, which was carried out during the end of May, returning it to its pre-transport condition.

Figs.15-16: Photographs of the display cases showing the final arrangement of ceramics for display (Photographs courtesy of Veronica Ford, 2017).
