FINAL REPORT SUMMARY:

THE CONSERVATION OF FINDS FROM
UNDERWATER EXCAVATIONS AND SURVEYS -
CONTRACT FOR THE PROVISION OF SERVICES
FOR THE DEPARTMENT OF ANTIQUITIES,
CYPRUS

Constantina Hadjivasili

April 2021

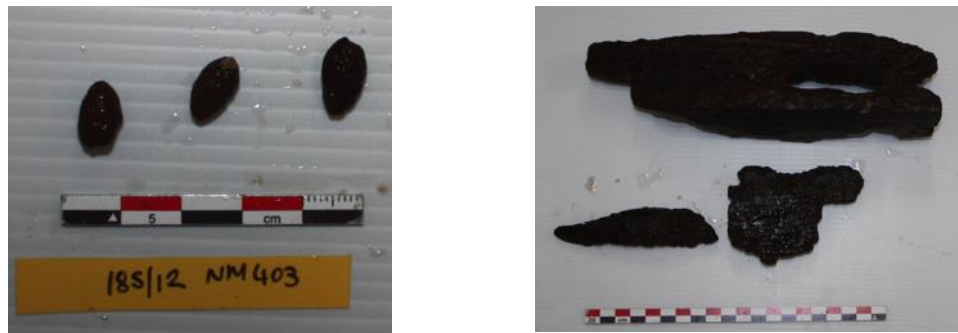
One of the main objectives of this contract was the photographic documentation of almost 370 organic objects (wood, olive pits, seeds), recovered from underwater excavations between 2008 and 2019. The organic objects were photographed to record their current condition and any possible visible change that may have occurred since their excavation (fig.5).

Fig. 5: Olive pits (ESEA 185-12) and wooden object (ESEA 364-18) during photographic documentation .
